FLOOD DAMAGE ASSESSMENT ALLYN RIVER SYSTEM ~ JUNE 2011 FLOOD EVENT

By Noel Jupp OAM, Dip Hort, QP Dept Ag & Fisheries.

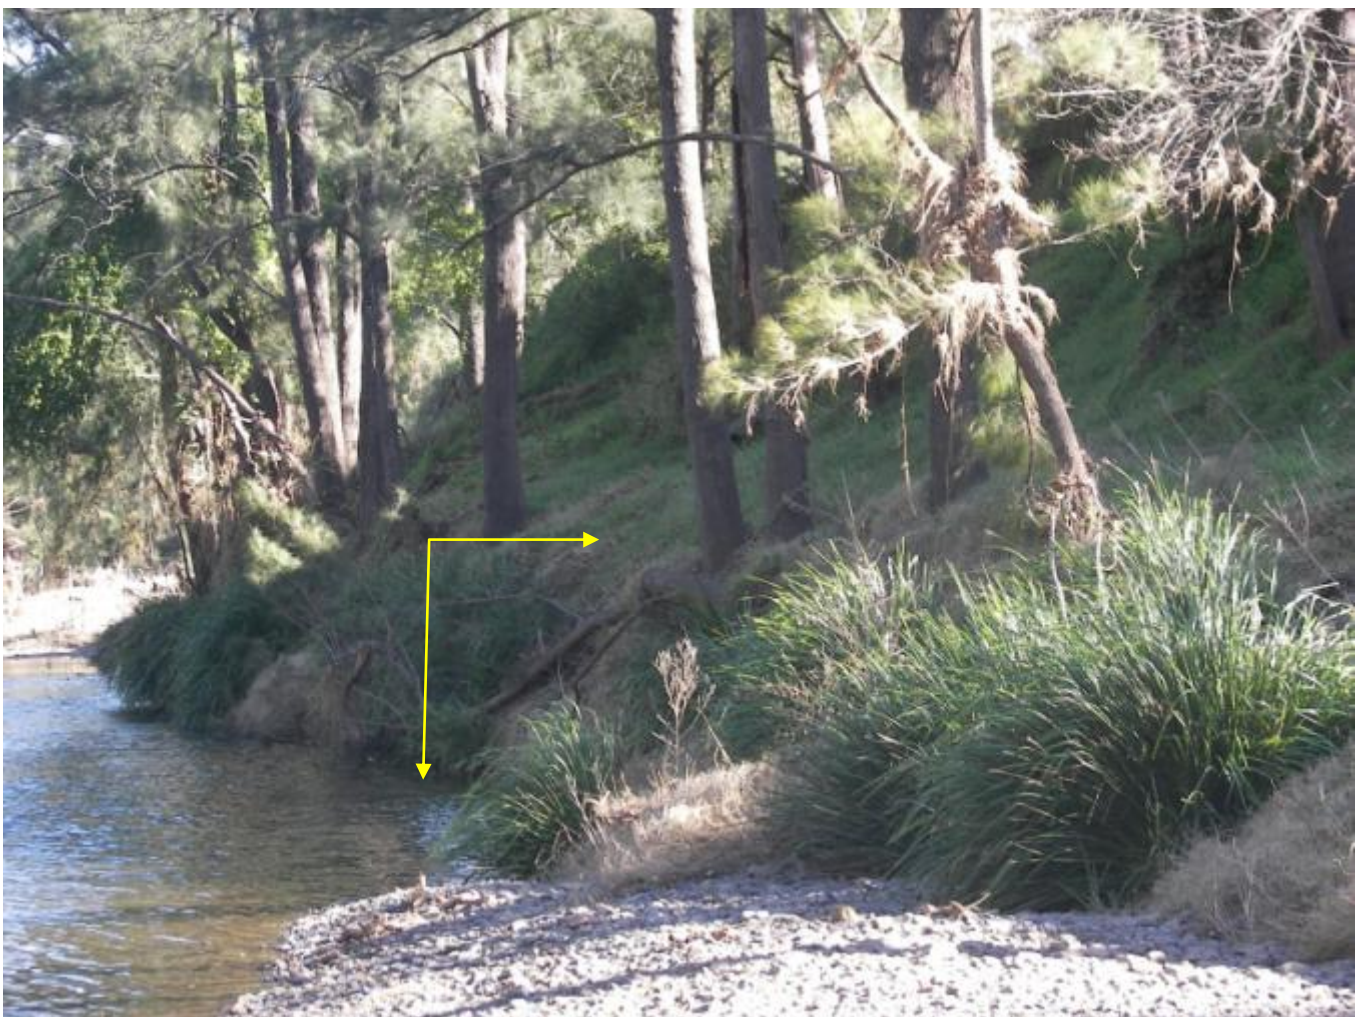
Prior to European settlement the banks of waterways had quite a steep grade with a single continuous slope from the upper river flats down to the toe of the bank as is illustrated in Figure 1. This same natural bank formation can still be seen in Figure 3 below, which is a photo of Allyn River bank area taken shortly after the flood of June 2011. Some flood debris can be seen caught on the branches of the Casuarina in the foreground which gives some indication of the water levels although it should be noted that the flood peaked well above that level. Note that the Casuarinas in Figure 3 are growing at least one metre above the water level and that these Casuarinas are growing in a significant depth of soil as indicated by the yellow arrow.

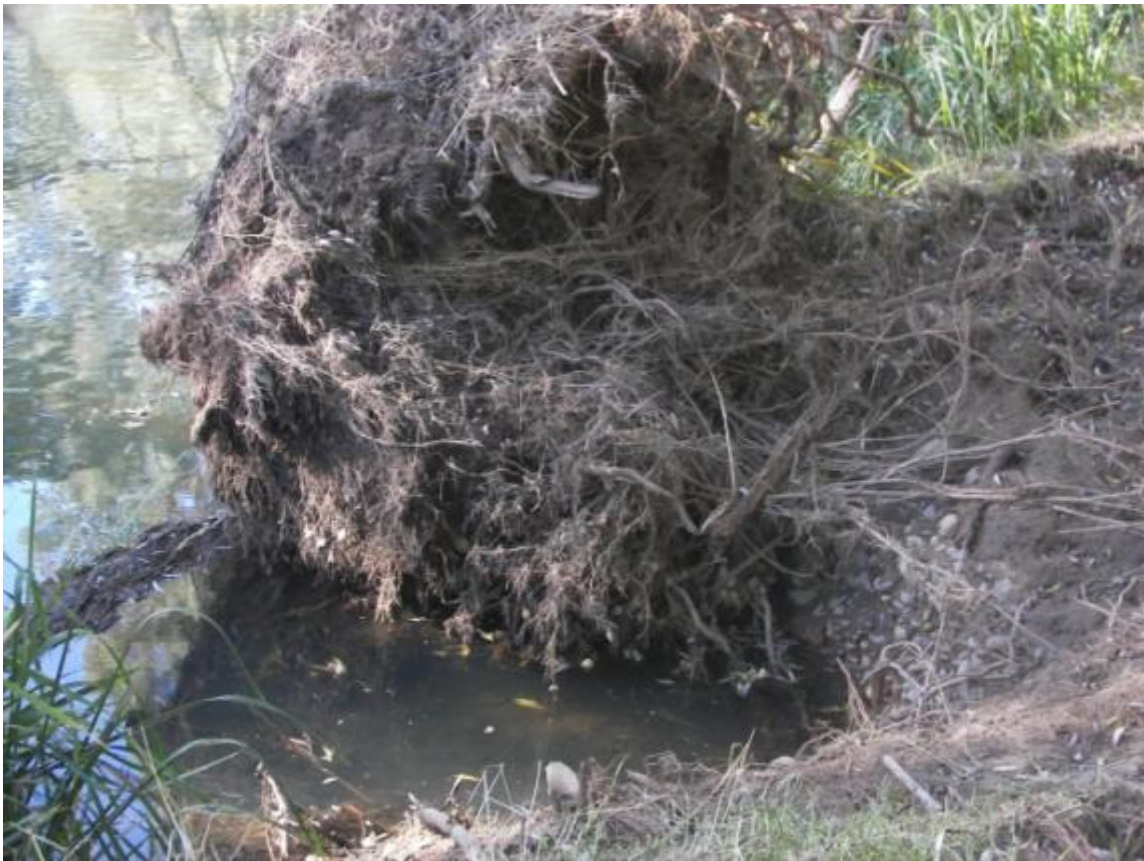
Past & current planting practises have seen a tendency to plant trees (Casuarinas in particular) on the Toe of the bank where there is only 30cms or so of “silty soil” over a bed of river gravel. The effectiveness of this practise is evident in Figure 4 below. This Casuarina was planted on the Southern bank of the Allyn River, slightly downstream of the Camyr Allyn Bridge. You will note the level of root formation is dense but shallow. The density of the root system is indicative of the fact that it was not a sapling that was dislodged before it had time to develop a good root system, however the shallowness of the root system is indicative of the fact that the roots of this tree did not have to venture deep into the soil to find enough water to sustain and promote a high growth rate.

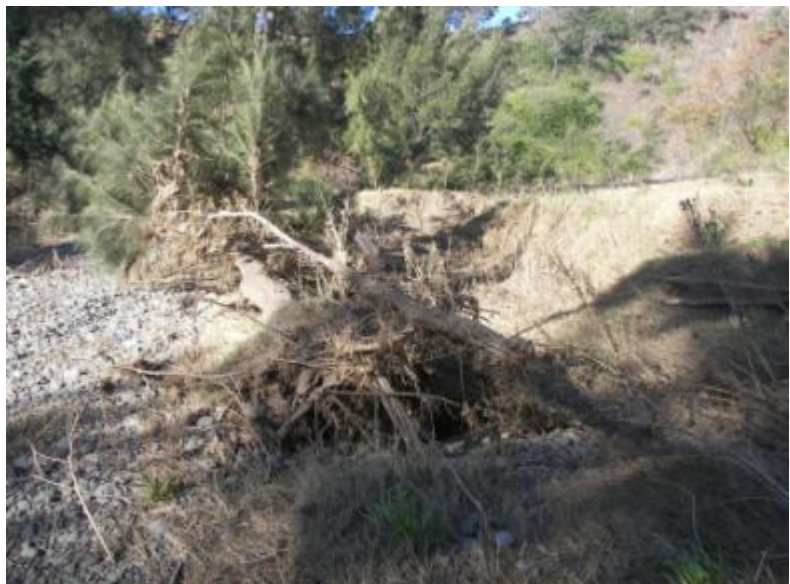
Figure 5 is 50m downstream of Figure 4. Although this particular specimen was not growing on the toe of the bank it was certainly growing in the same shallow gravelly conditions with ready access to water.

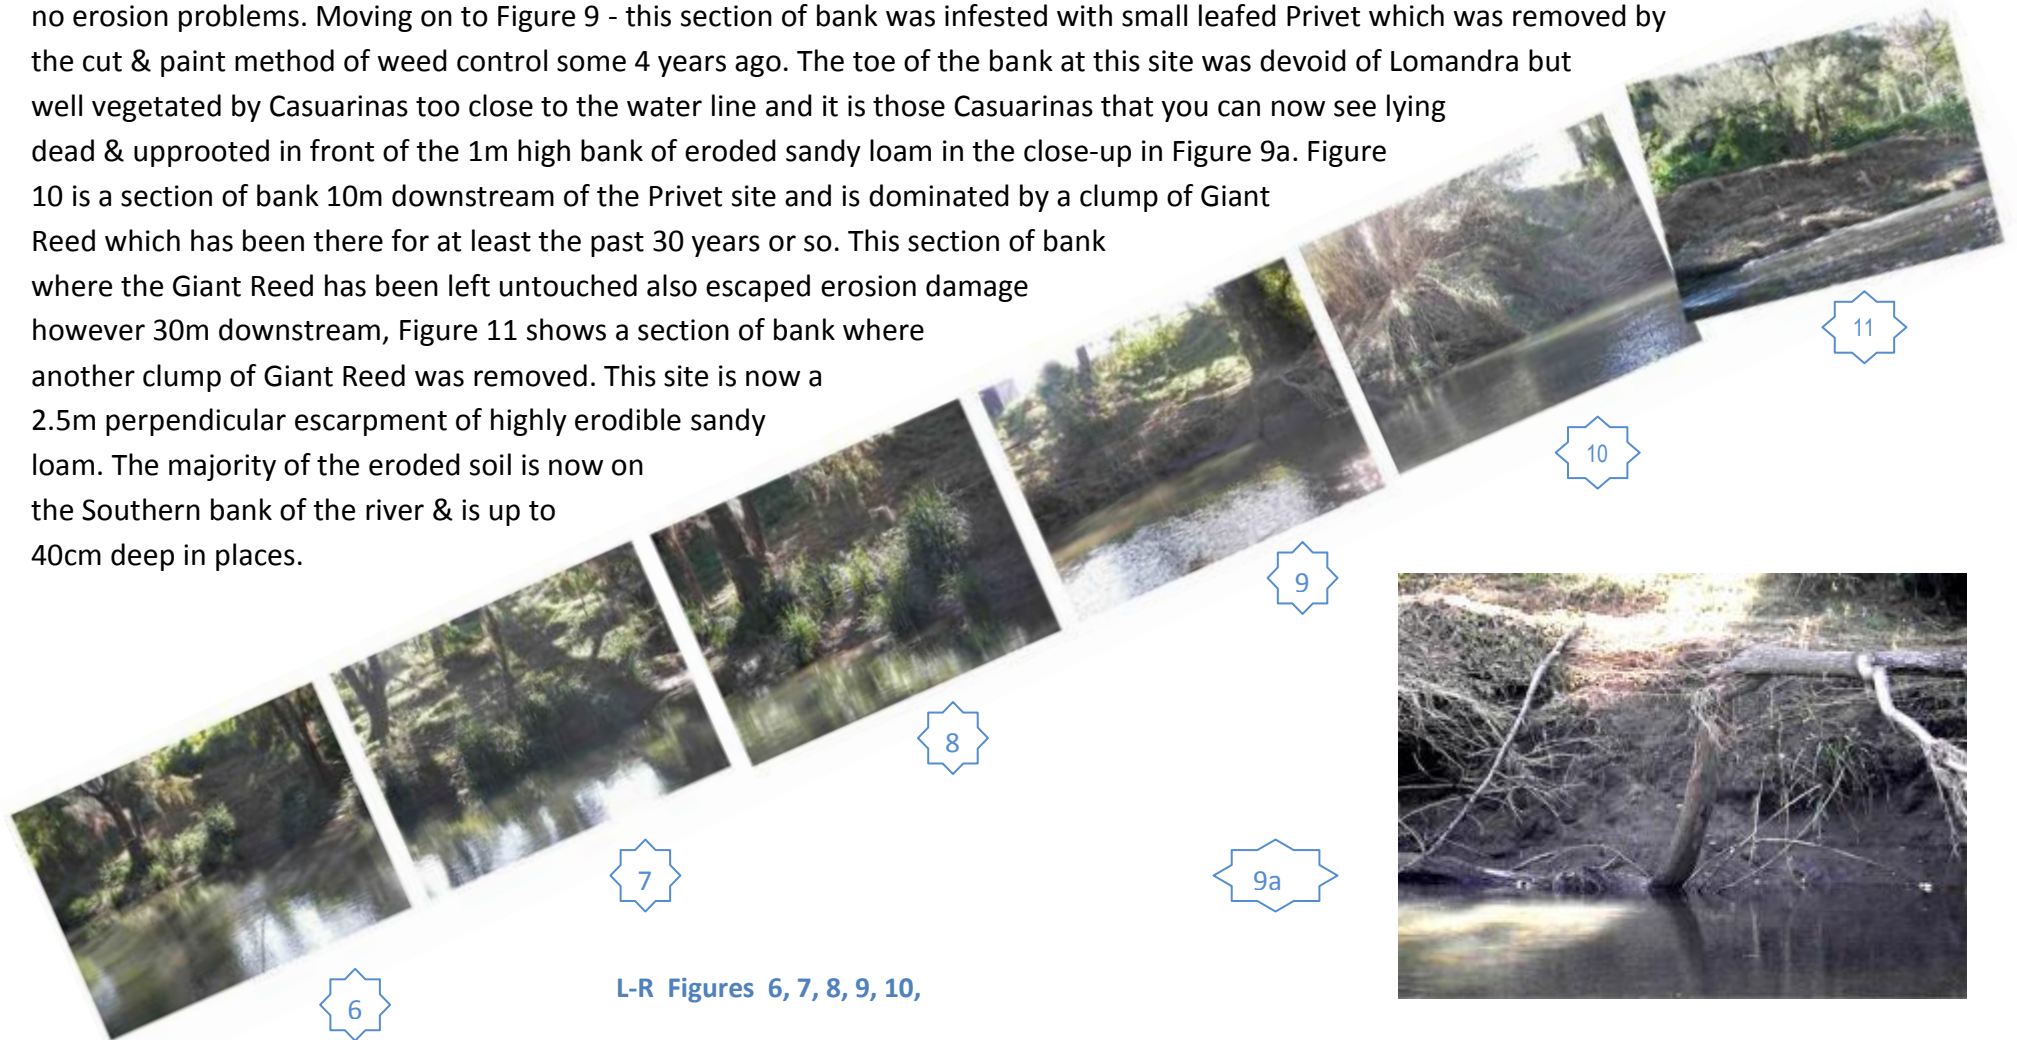
L-R Figures 6, 7, 8, 9, 10,

The collage of photos below is a reasonable flow chart type of representation of the progression and status of the Northern Bank of the Allyn River beginning just below the Camyr Allyn Bridge and extending 250 - 300m downstream to finish on a bend in the river. All these photographs were taken on the same day shortly after the June 2011 flood event and they tell the story better than I can. In the first instance all you have to do is play "Spot the Difference" between the first three photos and the last three. The plants on the toe of the bank in Figures 6, 7 & 8 are *Lomandra hystrix* and the majority of the trees are set well back from the edge of the water. This section of the river had no erosion problems. Moving on to Figure 9 - this section of bank was infested with small leafed Privet which was removed by the cut & paint method of weed control some 4 years ago. The toe of the bank at this site was devoid of *Lomandra* but well vegetated by *Casuarinas* too close to the water line and it is those *Casuarinas* that you can now see lying dead & uprooted in front of the 1m high bank of eroded sandy loam in the close-up in Figure 9a. Figure 10 is a section of bank 10m downstream of the Privet site and is dominated by a clump of Giant Reed which has been there for at least the past 30 years or so. This section of bank where the Giant Reed has been left untouched also escaped erosion damage however 30m downstream, Figure 11 shows a section of bank where another clump of Giant Reed was removed. This site is now a 2.5m perpendicular escarpment of highly erodible sandy loam. The majority of the eroded soil is now on the Southern bank of the river & is up to 40cm deep in places.

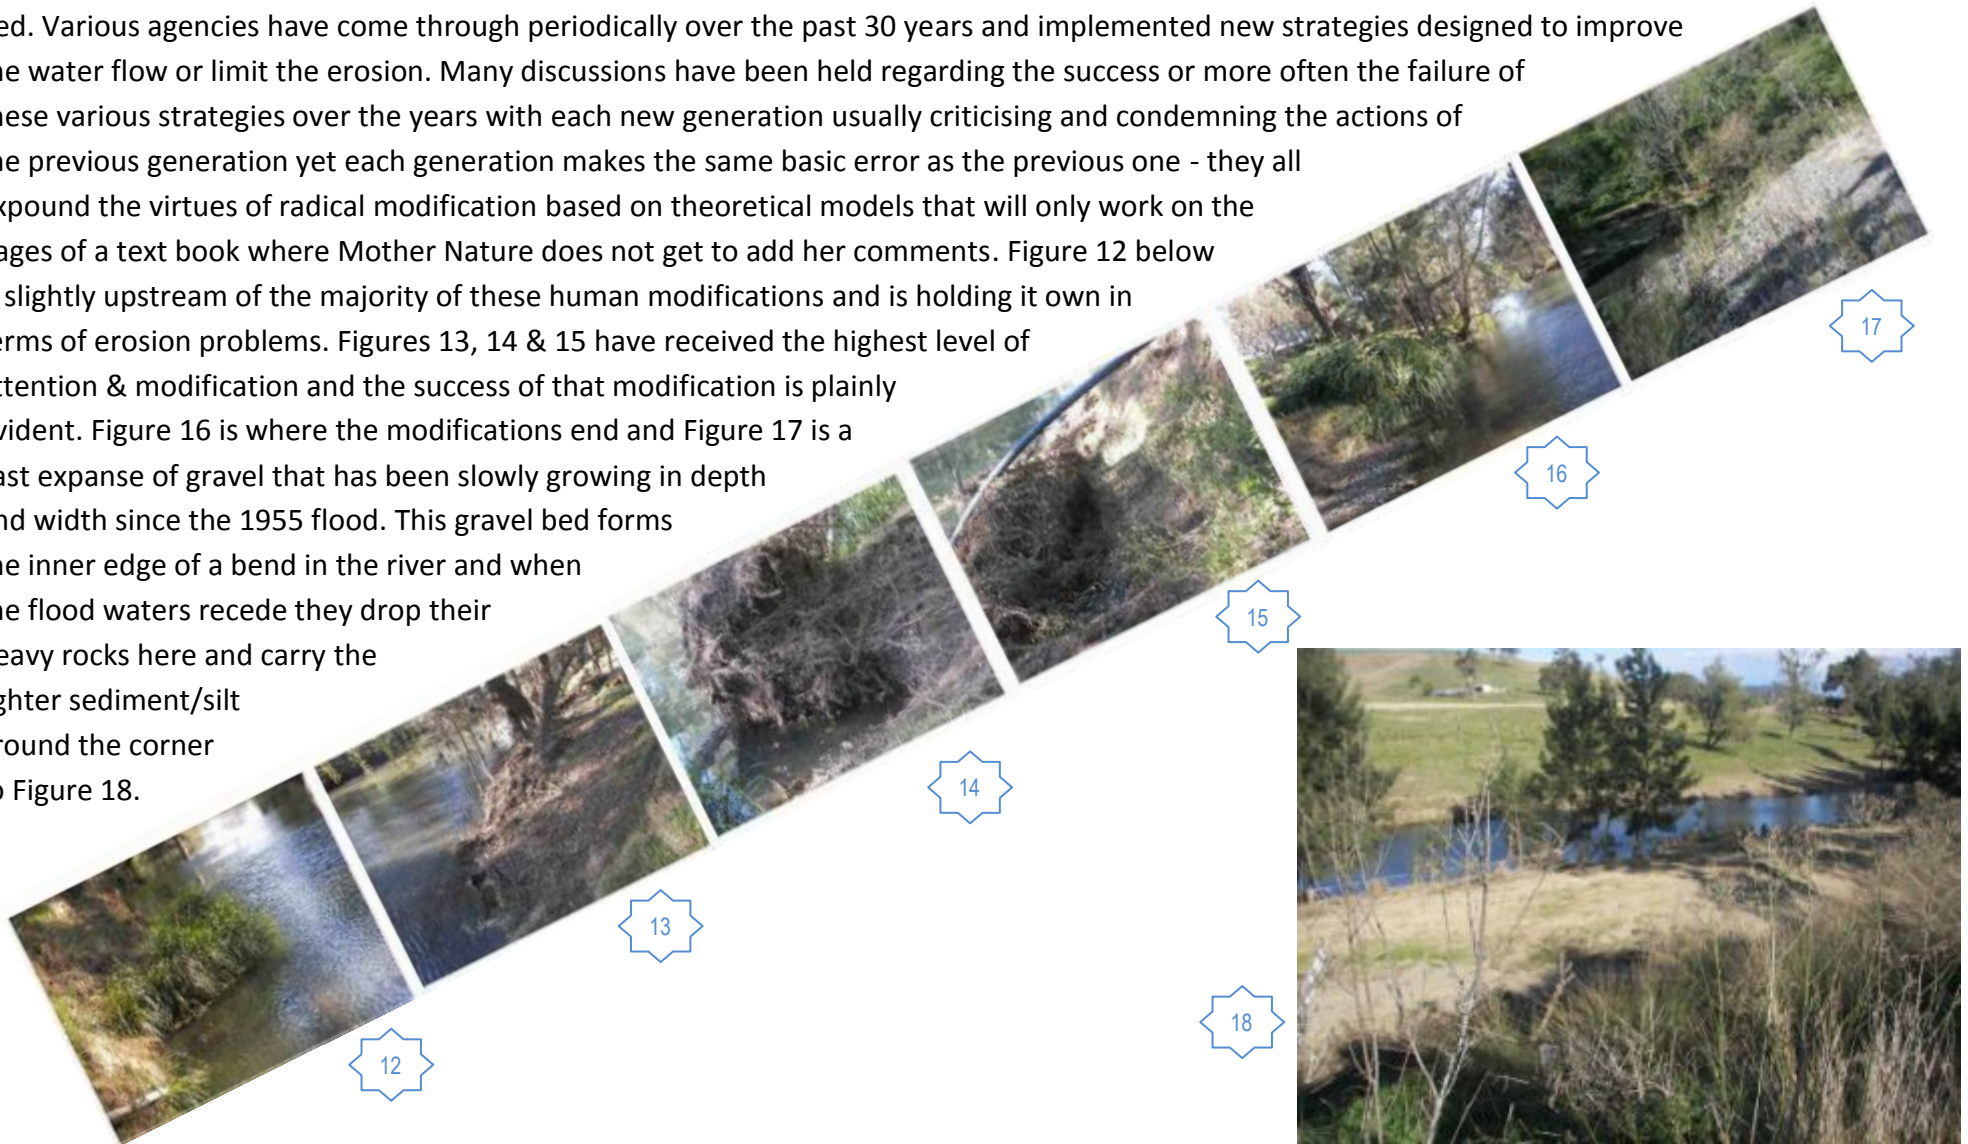
The Southern bank of the Allyn River has been subject to significant modification as a result of human intervention over the years. Its topography still reflects the remnants of the original river crossing and its access road. Its vegetation was modified in the 60's when the Water Resources came through and removed one species of willow and replaced them with another and removed all the "snags" from the river bed. Various agencies have come through periodically over the past 30 years and implemented new strategies designed to improve the water flow or limit the erosion. Many discussions have been held regarding the success or more often the failure of these various strategies over the years with each new generation usually criticising and condemning the actions of the previous generation yet each generation makes the same basic error as the previous one - they all expound the virtues of radical modification based on theoretical models that will only work on the pages of a text book where Mother Nature does not get to add her comments. Figure 12 below is slightly upstream of the majority of these human modifications and is holding it own in terms of erosion problems. Figures 13, 14 & 15 have received the highest level of attention & modification and the success of that modification is plainly evident. Figure 16 is where the modifications end and Figure 17 is a vast expanse of gravel that has been slowly growing in depth and width since the 1955 flood. This gravel bed forms the inner edge of a bend in the river and when the flood waters recede they drop their heavy rocks here and carry the lighter sediment/silt around the corner to Figure 18.

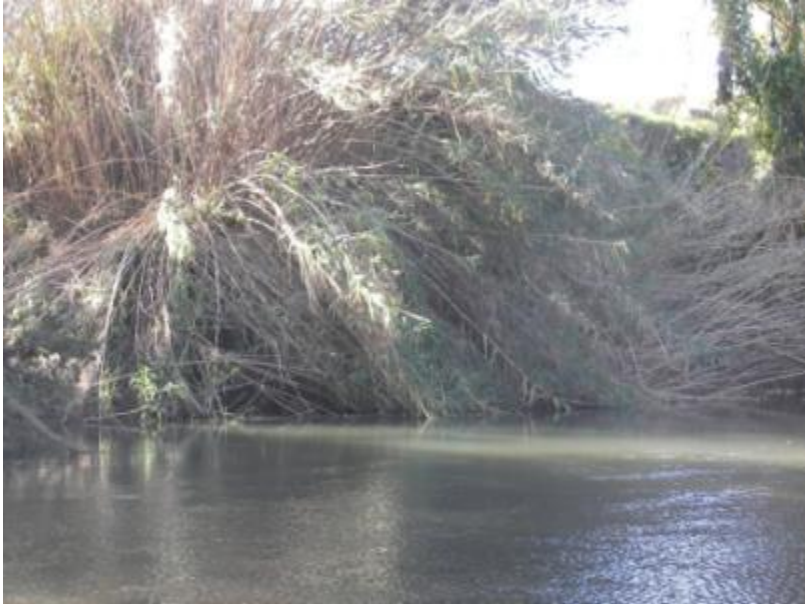
Figure 19

The theory of nominating Giant Reed, Willows & Privet as environmental weeds that must be eradicated as a priority action on our rivers and stream banks is a valid theory; however, in reality that priority action has created an environmental disaster.

Mother Nature does not read theory notes about weeds, rehabilitation and stabilisation and she is most certainly not renowned for her moderation. The current practise of wholesale removal of these weeds is achieving nothing more than an immediate and dramatic visual satisfaction that a good environmental deed has been done today.

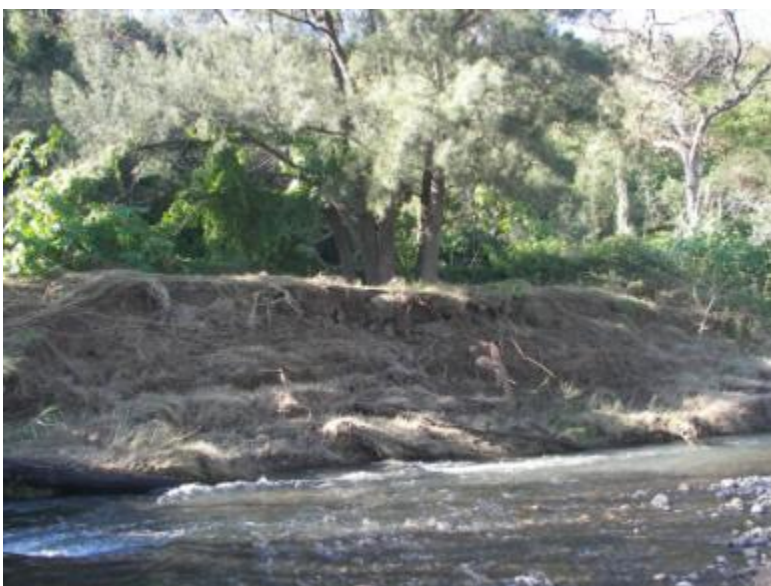
Figure 20

Points No 1 & 2 of the theory worked OK but instead of watching these sites flourish we have had to watch those sites (not just the seedlings that we planted but the entire site) wash away to parts unknown leaving us to not only contemplate the colossal waste of money that was spent but the creation of an environmental problem worse than the one we started with.

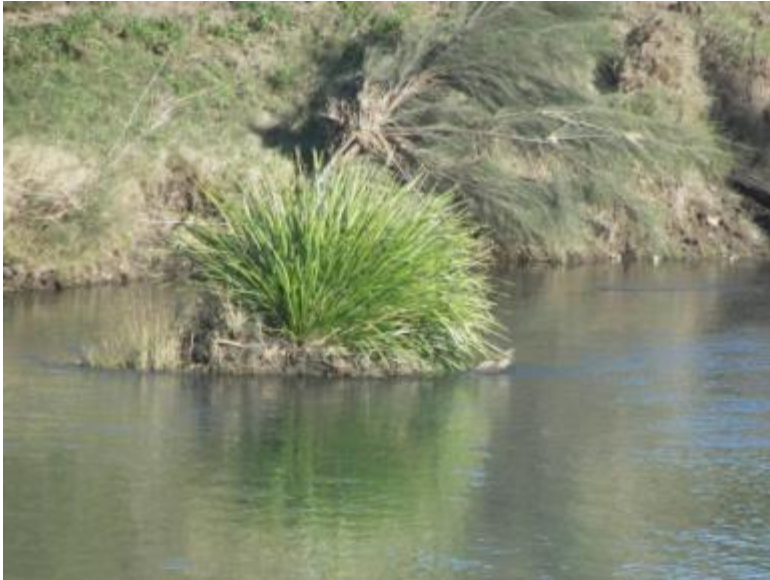
Figure 21 - Alice

In a major flood event Alice is covered with at least 7 metres of raging flood waters. She is battered by every bit of debris that those flood waters can carry and she emerges triumphant and unscathed every time.

Alice is not a theory, she is a fact and more than that she is living proof of the solution to the problem of bank stabilisation and erosion control.

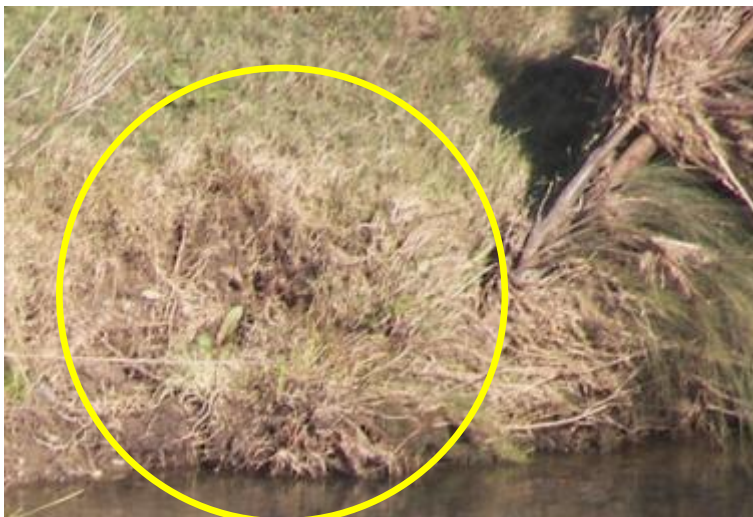
Note the *Casuarina* sapling on the riverbank behind Alice, its branches are full of debris and it is at a rather precarious angle. Although it has managed to hang on, its lateral position indicates that its roots have been dislodged or damaged. Figure 22 is a close-up of the root area of that sapling, note the portion of the bank that has slumped where the roots of that

sapling have been dislodged. Both Alice and the *Casuarina* sapling were subjected to the same flood force and Alice has obviously survived in a better condition than the *Casuarina*. Furthermore - if Alice had been growing alongside the *Casuarina*, it would have literally ripped the ground out from beneath her roots and dislodged her as well.

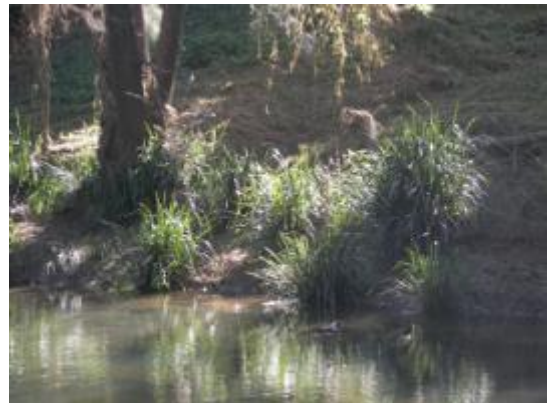
Allocation of individual project funding simply requires that a landholder firstly indicate that they want to transform their riverbank into some resemblance of Figure 23 and then provide a decent overview of the project which usually follows the well trodden path of FENCE IT OFF → REMOVE THE WEEDS → PLANT IT OUT WITH LOCAL PROVENANCE NATIVES (any will do) and providing the entire project can be completed in a timely fashion, it gets approval for funding.

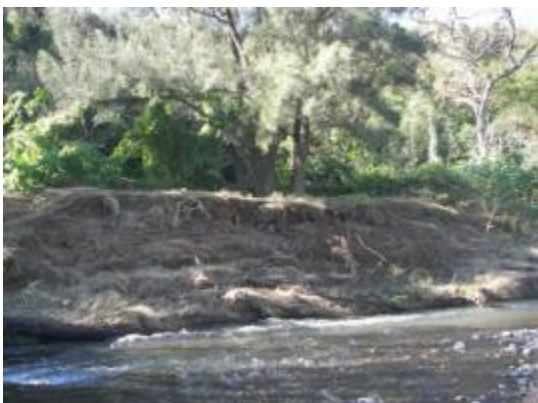
The site shown in Figure 24 has been fenced off from stock for several years, it had a clump of giant weed removed and in theory should be well on its way to emulating a natural well balanced vegetated site with its predetermined 20% of this and 10% of that native species growing and flourishing happily.

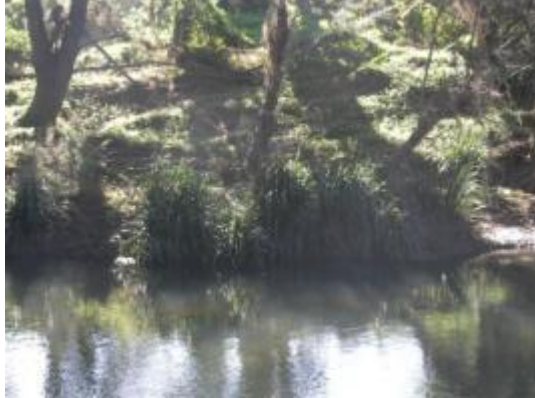
<p>This site is relatively stable and although it could support additional plantings, there is no clear or present danger of any problems that would be detrimental to the site. Funding assessment level - LOW</p>

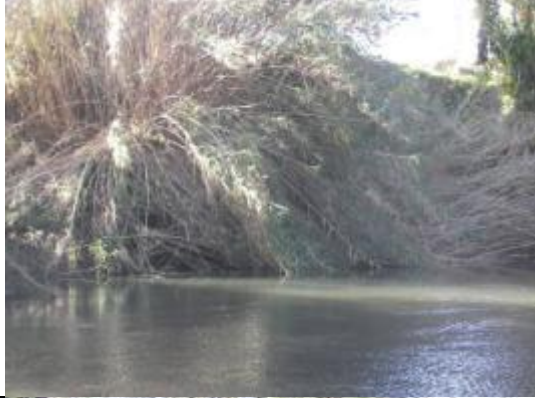
<p>Forget the giant reed for the time being – this clump has been here for over 30 years. These clumps of giant reed have not spread uncontrollably over the rest of the river bank for the past 30 years and they are not likely to start now. Their progression is slow and so should be their removal, section by section & bit by bit. Funding assessment level – MEDIUM</p>

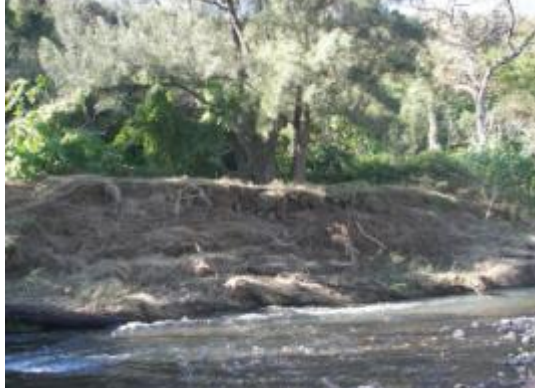
<p>This site obviously has a problem and needs attention as soon as possible. It should be agreed that this site is eligible for immediate funding and it should be progressed to Step 2 which would be to develop a plan for that site that will address the specific problems of that site. Funding assessment level - HIGH to APPROVED</p>

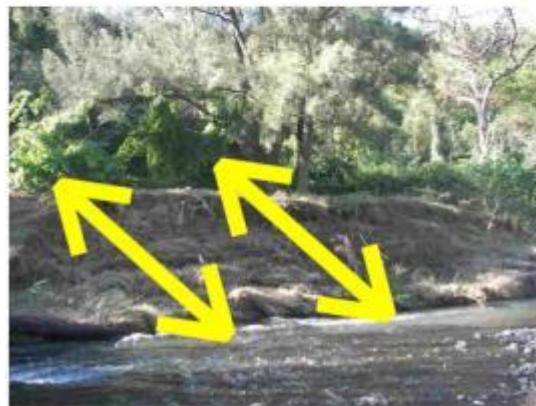
Perpendicular eroded banks like this one have traditionally been planted out with a high density of trees, shrubs and groundcovers based on the theory that their roots will hold it all together. In reality, that practise has had a 100% failure rate because vegetation of that nature requires at least 4 -5 years growth in-situ to have any kind of binding effect on the soil around it.

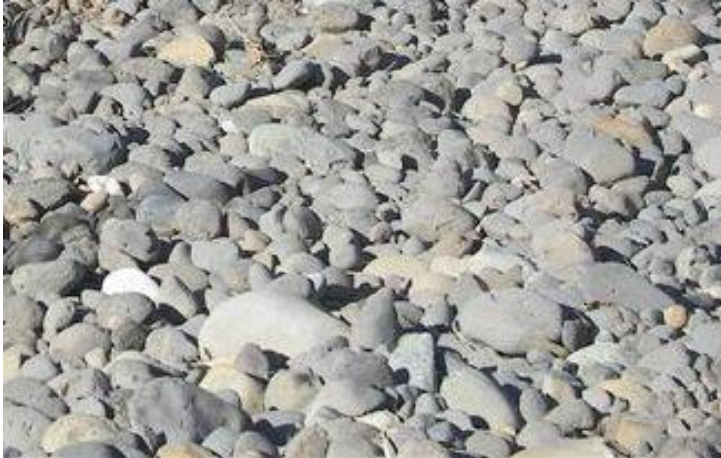
What about those huge expanses of gravel deposits on every inside bend of the river? These river rocks are Mother Nature's toys; she picks them up, plays with them for a while & then drops them in a pile somewhere when she gets tired of them. These piles of discarded rocks are growing and can be up to 1.5m deep and you cannot plant them out to stabilise them

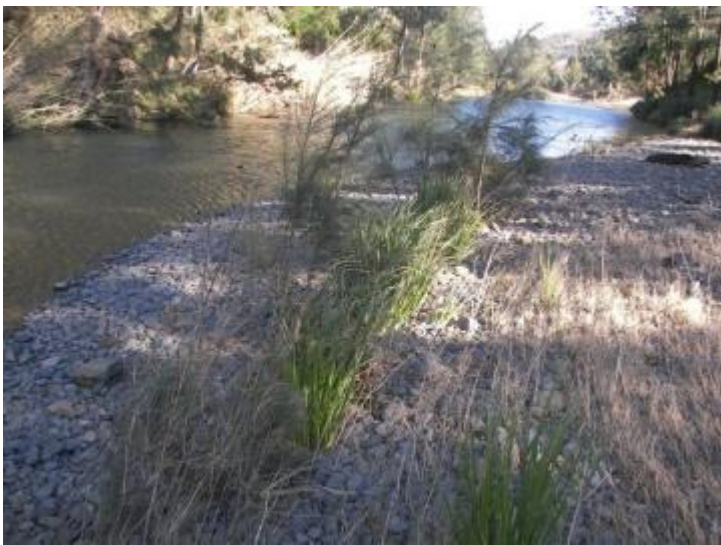
This is the site of a direct seeding experiment using Lomandra & Casuarina to try & stabilise the gravel bed. In hindsight the Casuarina is not a good idea & will be replaced by a better species choice, however their germination has shown that the technique is sound. That technique simply involved placing small branchlets of Casuarina with seed capsules or

entire seed heads of Lomandra on top of the gravel bed, anchored in place with a rock or two. The small branches were left with their leaves and seed stalks intact to shade the seed from the intense heat generated by the sun on the gravel, or in the case of the Lomandra, the entire seed head. Nature was then allowed to take its own course and as soon as we had a bit of cool showery weather, the seed germinated successfully and not only have the plants been thriving ever since, they did not budge during the recent flood event.

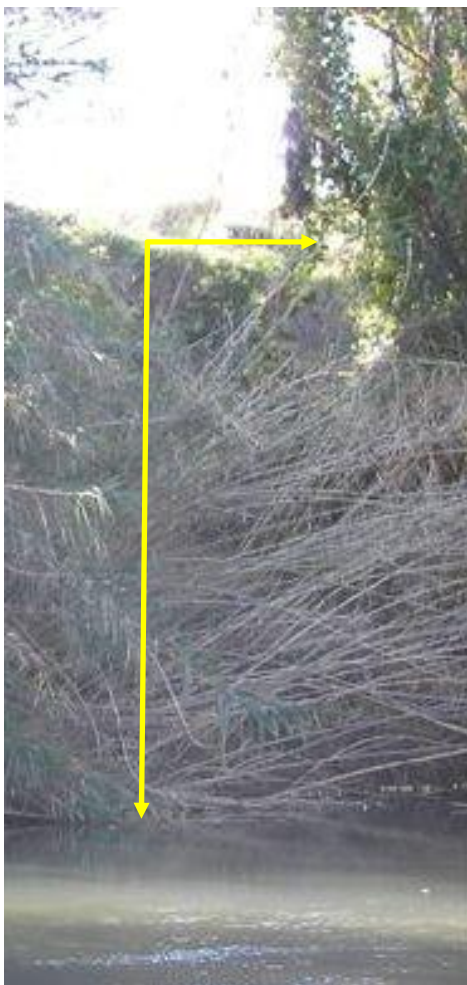
The topography of the bank behind the arching stems of the clump of Giant Reed pictured on the left (indicated by the yellow arrow) is a 12- 15m vertical eroded wall of soil created by previous flood events. It should be noted that this erosion occurred before the clump took up residence. The rhizomes of the clump itself do not extend up the entire bank; they are limited to the toe of the bank where the moisture is constant, however the fragile walls are protected by the dense tangle of stems. This vertical wall of exposed soil extends further to the left behind the Giant Reed & takes a sharp turn Northward to form the Eastern bank of a large eroded hole created when the waters from a tributary gully/creek ploughed a channel to the river. That bank is also a 12m vertical wall of pure soil.

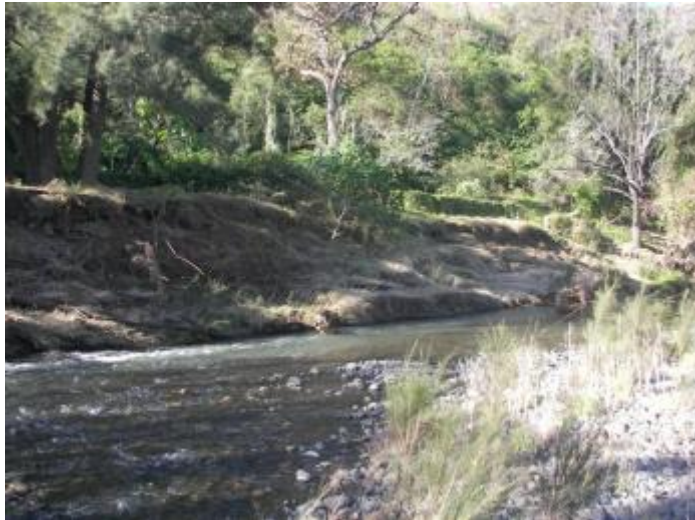
The last clump of Giant Reed that was removed from this river bank resulted in the loss of approximately 200 cubic metres of soil.

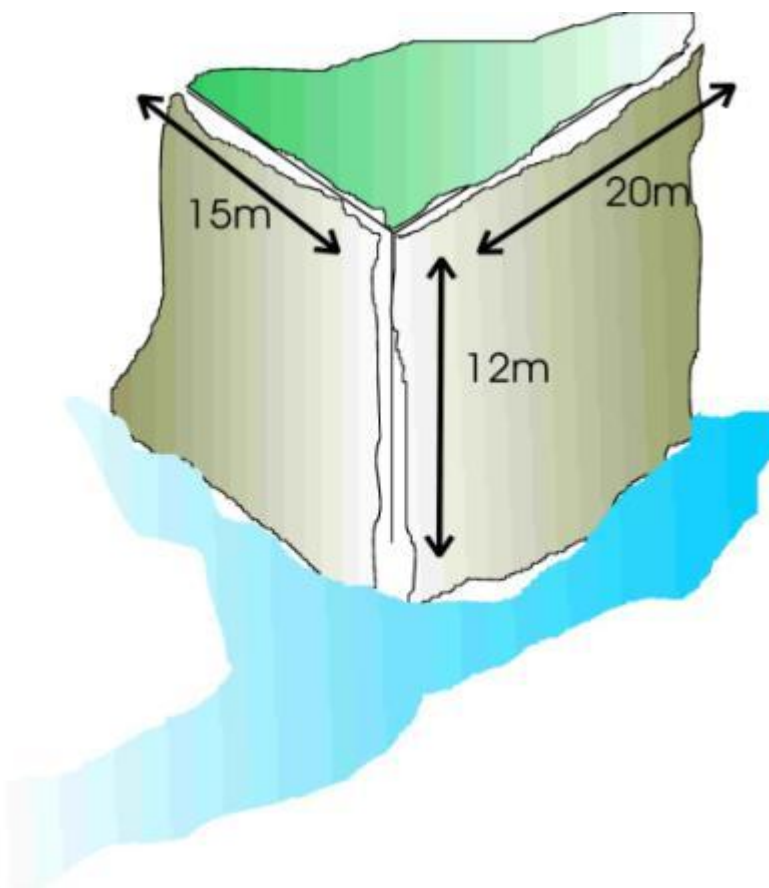
If the clump of Giant Reed that is protecting both sides of this fragile soil embankment is removed it is highly likely, if not a certainty that anything up to 1,000 cubic meters of unsupported soil will collapse into the river when the first minor flood waters come in contact with it. We must be able to come up with a better plan to avoid disaster instead of creating it. Simply removing the Giant Reed does not solve the problem; it simply exposes the original & possibly bigger problem that has remained hidden & protected behind that tangle of canes for many years.
