FLOOD DAMAGE ASSESSMENT ALLYN RIVER SYSTEM ~ JUNE 2011 FLOOD EVENT

By Noel Jupp OAM, Dip Hort, QP Dept Ag & Fisheries.

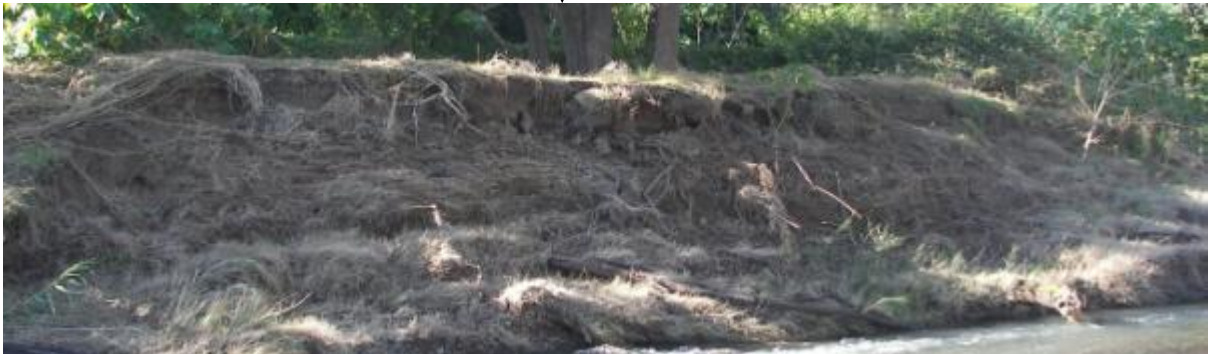
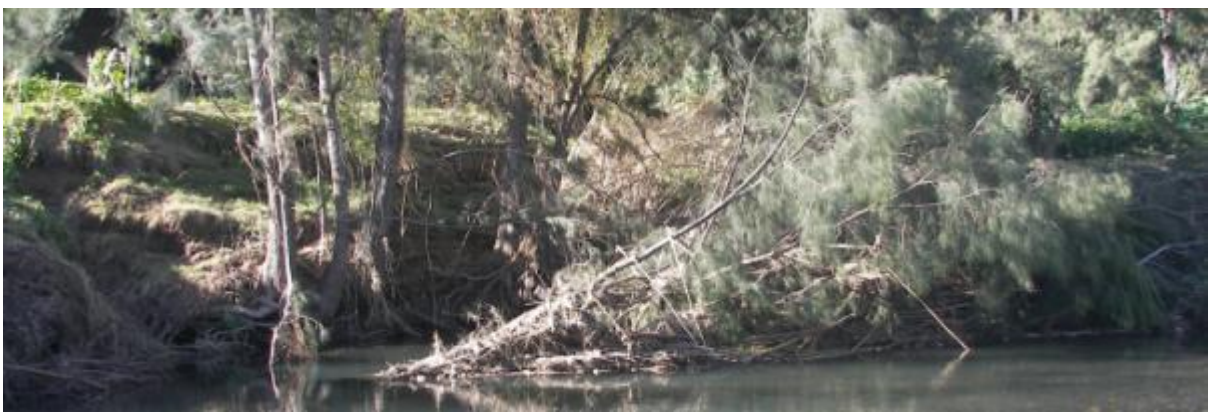
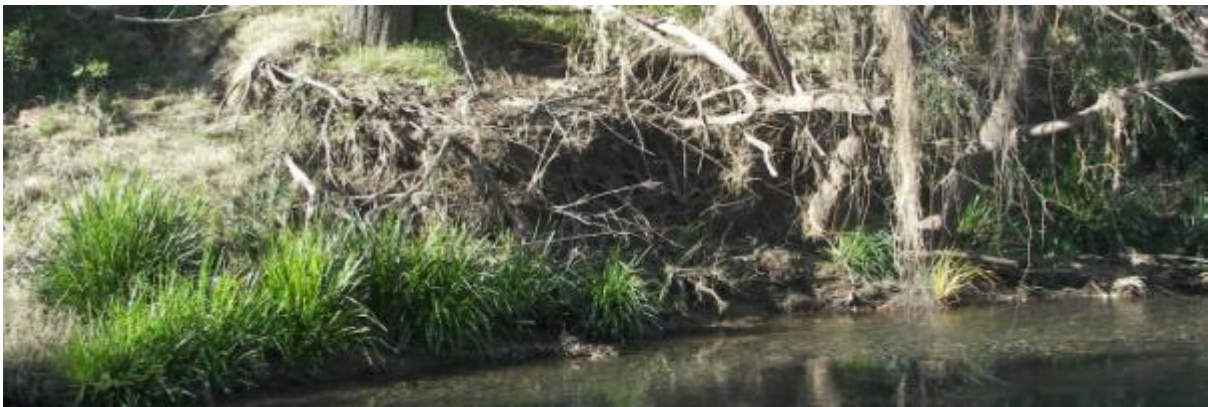
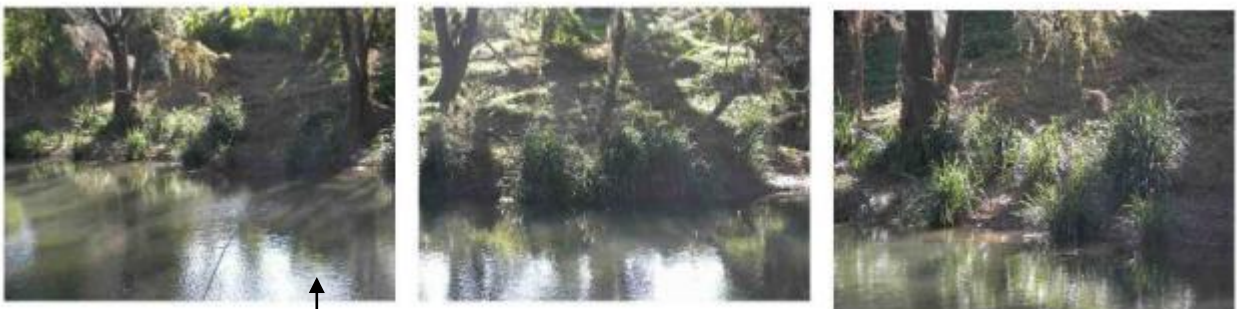
We need to get from this DISASTER to.....

this stability & we can't do it overnight. Rushing so we could see an immediate result in time for the next budget allocation is how we created this disaster in the first place.

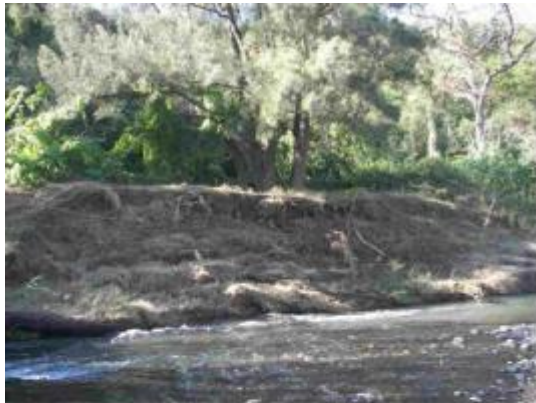
<p>This site obviously has a problem and needs attention as soon as possible. It should be agreed that this site is eligible for immediate funding and it should be progressed to Step 2 which would be to develop a plan for that site that will address the specific problems of that site. Funding assessment level - HIGH to APPROVED</p>

Our sights should not be on the “goal posts” at this point in time, they should be concentrated on undertaking and fixing the immediate problems and ensuring that the solution has really solved the problem before we take the next step. Emulating the natural environment just the way Mother Nature made it 100 years ago is going to take time (possibly another 100 years), and it is foolish to think it can be done over the course of a fiscal year.

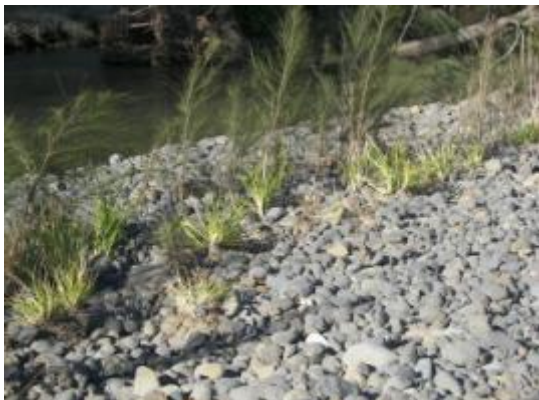
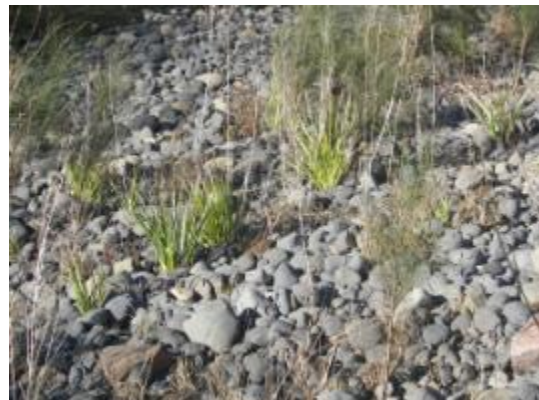
This is the site of a direct seeding experiment using Lomandra & Casuarina to try & stabilise the gravel bed. In hindsight the Casuarina is not a good idea & will be replaced by a better species choice, however their germination has shown that the technique is sound. That technique simply involved placing small branchlets of Casuarina with seed capsules or

entire seed heads of Lomandra on top of the gravel bed, anchored in place with a rock or two. The small branches were left with their leaves and seed stalks intact to shade the seed from the intense heat generated by the sun on the gravel, or in the case of the Lomandra, the entire seed head. Nature was then allowed to take its own course and as soon as we had a bit of cool showery weather, the seed germinated successfully and not only have the plants been thriving ever since, they did not budge during the recent flood event.
